**Flood Control Project Maintenance
Levee Inspections****LMA District Cover Sheet****Spring 2016 Levee Inspection Results****Sacramento River West Side Levee District**

Spring 2016 Levee Inspection Results

Sacramento River West Side Levee District

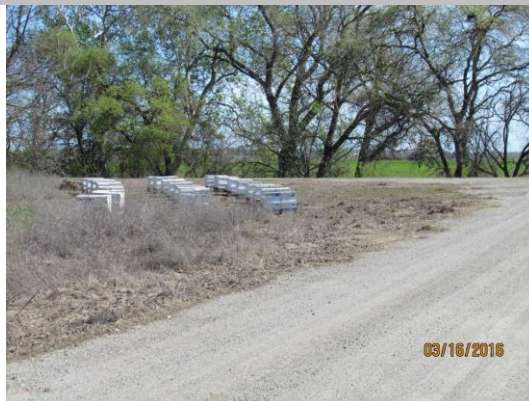
Photo 1 of 1 : SP_2016_NA0016_435_227_20160328_00282.jpg

LM Start	44.31	Rating **	M	Issue No.	227
LM End	44.31	Issue Type +	En	Location *	WS
Category	Earthen Levee			GPS Latitude/Longitude	
				Start	End
Item	Encroachments			39.189010 °	39.189010 °
				-121.939915 °	-121.939915 °
DWR ID	DWR_NA0016_01_s _ 2016_227				
Comment Code					
BU : Building					
Inspector Comment					
Beehives are on the waterward side of the levee.

View of the beehives on the waterward side of the levee looking downstream. Spring 2016.

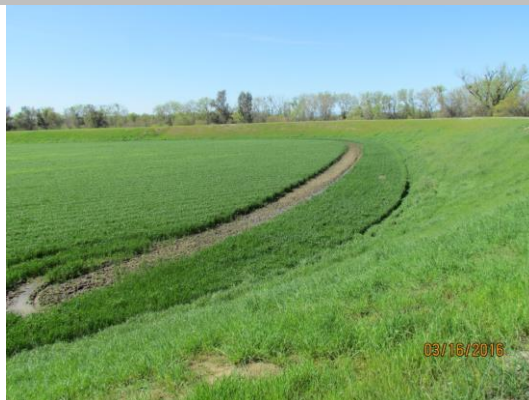
Photo 1 of 1 : SP_2016_NA0016_435_228_20160328_00283.jpg

LM Start	44.87	Rating **	U	Issue No.	228
LM End	45.23	Issue Type +	Ob	Location *	LS
Category	Earthen Levee			GPS Latitude/Longitude	
				Start	End
Item	Seepage / Sandboils			39.195595 °	39.193890 °
				-121.945408 °	-121.950276 °
DWR ID	DWR_NA0016_01_s _ 2016_228				
Comment Code					
Inspector Comment					
Seepage site is being monitored by LMA.

View of the seepage on the landward side of the levee looking upstream. Spring 2016.

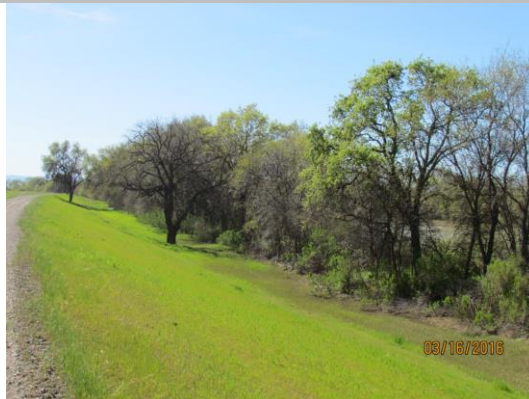
Photo 1 of 2 : SP_2016_NA0016_435_108_20160328_00286.jpg

LM Start	45.39	Rating **	A/W	Issue No.	108
LM End	45.90	Issue Type +	Ob	Location *	WS
Category	Earthen Levee			GPS Latitude/Longitude	
				Start	End
Item	Vegetation			39.192653 °	39.188518 °
				-121.952768 °	-121.960446 °
DWR ID	DWR_NA0016_01_s _ 2015_108				
Comment Code					
V8 : Environmental Requirements.					
Inspector Comment

View of the revegetation site on the waterward side of the levee looking upstream. Spring 2016.

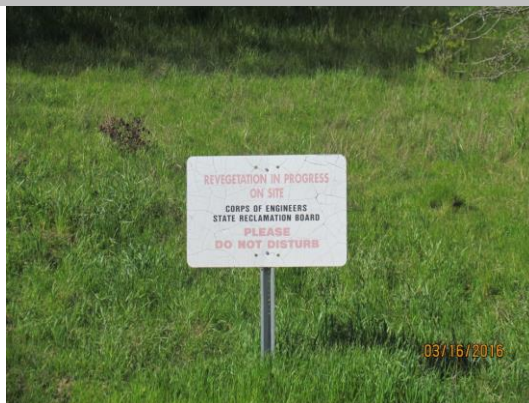
Photo 2 of 2 : SP_2016_NA0016_435_108_20160328_00284.jpg

Sign stating revegetation site. Spring 2016.

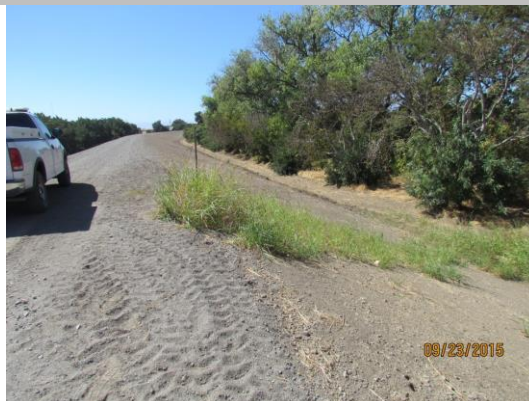
Photo 3 of 6 : SP_2016_NA0016_435_109_20160304_00056.jpg

LM Start	46.01	Rating **	A/W	Issue No.	109 (cont)	
LM End	46.01	Issue Type +	En	Location *	WS	
Category	Earthen Levee			GPS Latitude/Longitude		
				Start	End	
Item	Encroachments			39.187479 °	39.187479 °	
				-121.962081 °	-121.962081 °	
DWR ID	DWR_NA0016_01_s _ 2015_109					
Comment Code						
PI : Pipe						
Inspector Comment						
The siphon filter is fixed. There is no external leak on the levee from the pipe, however there are vegetation growing in line with the pipe. Update 3/16/2016: Seems some maintenance was done on pipe. Vegetation on top of pipe is removed.

Perspective view of the vegetation where the pipe runs through the levee on the waterward side of the levee looking upstream. Fall 2015.

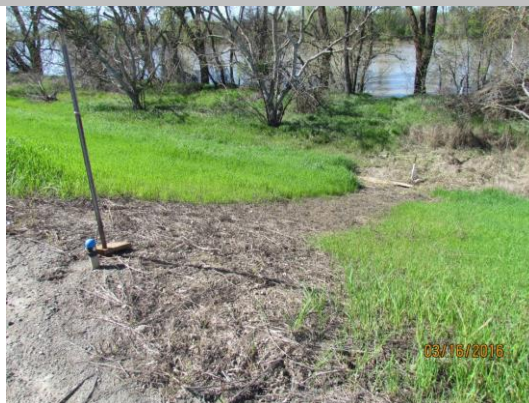
Photo 4 of 6 : SP_2016_NA0016_435_109_20160328_00293.jpg

Non-vegetated seems to align with the pipe. Spring 2016.

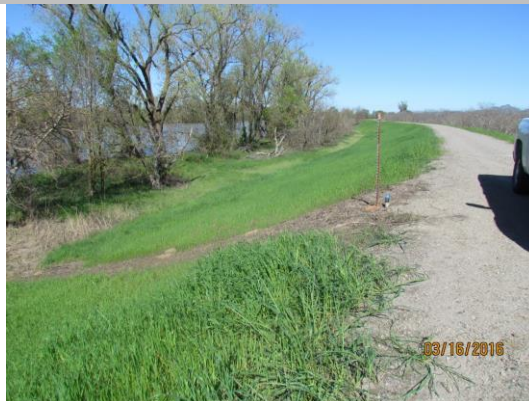
Photo 5 of 6 : SP_2016_NA0016_435_109_20160328_00287.jpg

Perspective view of the non-vegetated area where the pipe seems to run through the levee looking downstream. Spring 2016.

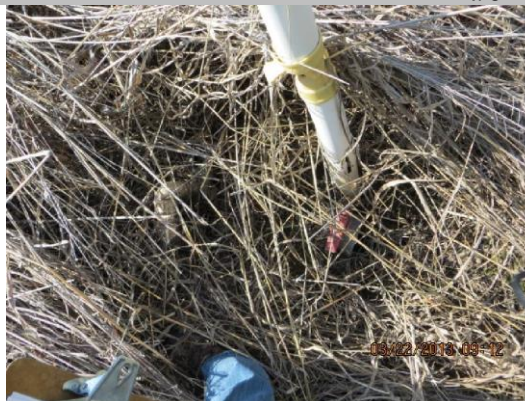
Photo 2 of 2 : UCIP_SP_2016_46812_17908.jpg

Item	DWR UCIP Field Study			39.187497 °		39.187497 °
				-121.962074 °		-121.962074 °
DWR ID						
Comment Code						
Inspector Comment						
FS_ID:46812 DS_ID:20314 EP_NO: 15763 Repair Type: Non-Urgent Crossing Status: Found UCIP Comments: Fresno valve on WS shoulder is broken. Pipe appears to be abandoned. Need to abandon properly if necessary. site visit on 10/09/2015 indicates water is present somewhere along the waterside levee slope. Possibly siphon breaker or fresno valve sprays and drains down levee slope from WS shoulder. internal inspection of pipe recommended to determine source of leak. Pipe is active, but can be removed and capped when not in use. FIELD_STRUCT_DESC: 4-inch galvanized steel irrigation pipe through levee 2.0 feet below crown. Irrigation valve approx. 50 feet landward of the landward levee toe. Fresno valve on WS shoulder with connection for pump at WS berm. (Permit No. 15763, 1992). FS Date: 3/22/2013

Pipe connection at WS toe.

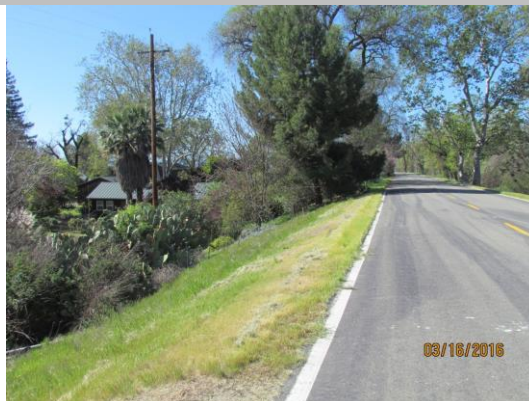
Photo 1 of 1 : SP_2016_NA0016_435_54_20160328_00294.jpg

LM Start	47.01	Rating **	M	Issue No.	54
LM End	47.14	Issue Type +	En	Location *	LS
Category	Earthen Levee			GPS Latitude/Longitude	
				Start	End
Item	Vegetation			39.188544 °	39.189733 °
				-121.979272 °	-121.981232 °
DWR ID	DWR_NA0016_01_s _ 2012_54				
Comment Code					
V6 : Landscaping					
Inspector Comment					
Cactus on slope and toe of levee, landscape continues along roadway with fence and stairs.

View of the revegetation on the landward side of the levee looking upstream. Spring 2016.

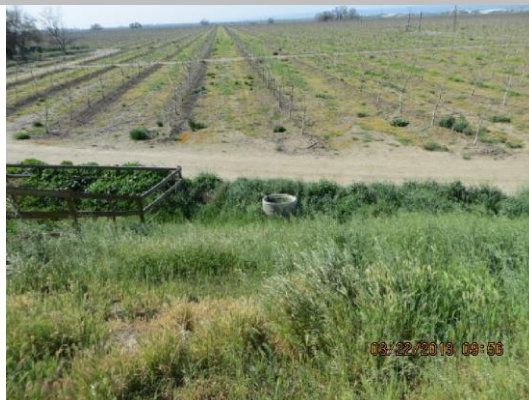
Photo 1 of 1 : UCIP_SP_2016_10553_17929.jpg

LM Start	47.16	Rating **	M	Issue No.	1552
LM End	47.16	Issue Type +	En	Location *	LS
Category	Supplemental			GPS Latitude/Longitude	
				Start	End
Item	DWR UCIP Field Study			39.189783 °	39.189783 °
				-121.981548 °	-121.981548 °
DWR ID					
Comment Code					
Inspector Comment					
FS_ID:10553					
DS_ID:20298					
EP_NO: 9347					
Repair Type: Non-Urgent					
Crossing Status: Indicator Found					
UCIP Comments: Need to verify type of abandonment.					
FIELD_STRUCT_DESC: 1 of 2: 24-inch pipe through levee 25.5 feet below crown. 14-inch pipe sleeved through this pipe. Annular space grouted. Pump in pump house on the landward side. Gate valve in pump house (ABO No. 9347, 1960). Originally included in the 1960 O&M manual.					
FS Date: 3/22/2013

Possible location for pipe crossing.

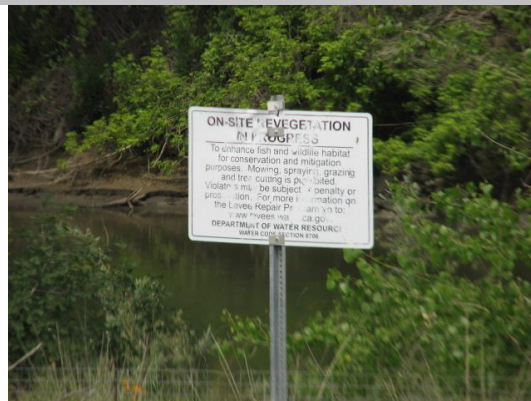
Photo 1 of 1 : SP_2016_NA0016_435_90_20160304_00044.jpg

LM Start	47.19	Rating **	A/W	Issue No.	90
LM End	47.62	Issue Type +	Ob	Location *	WS
Category	Earthen Levee			GPS Latitude/Longitude	
				Start	End
Item	Vegetation			39.189930 °	39.193491 °
				-121.982143 °	-121.988184 °
DWR ID	DWR_NA0016_01_s_2014_90				
Comment Code					
V8 : Environmental Requirements.					
Inspector Comment

A revegetation site along the waterside berm. Spring 2014

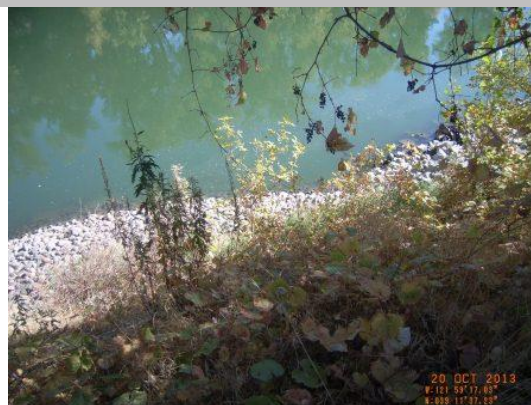
Photo 1 of 1 : SP_2016_NA0016_435_3_20160304_00003.jpg

LM Start	47.62	Rating **	A/W	Issue No.	3
LM End	47.77	Issue Type +	Ma	Location *	WS
Category	Supplemental			GPS Latitude/Longitude	
				Start	End
Item	2015 USACE Erosion Survey, DRAFT			39.193769 °	39.195595 °
				-121.987901 °	-121.988621 °
DWR ID	DWR_NA0016_01_s_2016_3				
Comment Code					
Inspector Comment					
2010 - Old cobble site starting to unravel at toe. 2011 - Cobbles continue to unravel. 2013 - Site extended downstream to revetment. 2015: No observed changes. [2015 Site ID: SAC_141-5_R]

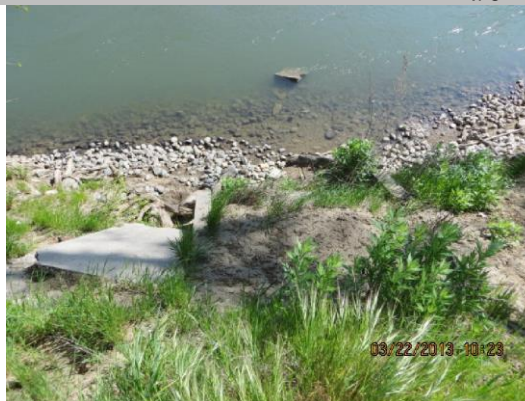
Photo 1 of 2 : UCIP_SP_2016_10563_17941.jpg

LM Start	47.71	Rating **	M	Issue No.	1553
LM End	47.71	Issue Type +	En	Location *	WS
Category	Supplemental			GPS Latitude/Longitude	
				Start	End
Item	DWR UCIP Field Study			39.194772 °	39.194772 °
				-121.988886 °	-121.988886 °
DWR ID					
Comment Code					
Inspector Comment					
FS_ID:10563 DS_ID:20309 EP_NO: 9347 Repair Type: Non-Urgent Crossing Status: Indicator Found UCIP Comments: Need to determine type of abandonment. FIELD_STRUCT_DESC: 2 of 2: *Removed*16-inch steel pipe through levee 17.3 feet below crown. Gate valve on the waterward end. Pump on the waterward bank. Switch box on the waterward shoulder. (ABO No. 9347,1960). Originally included in the 1960 O&M manual. FS Date: 3/22/2013

Concrete pumphouse debris on WS berm.

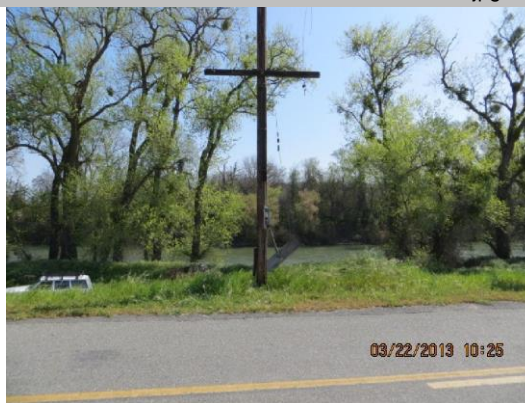
Photo 2 of 2 : UCIP_SP_2016_10563_17940.jpg

LM Start	47.71	Rating **	M	Issue No.	1553 (cont)
LM End	47.71	Issue Type +	En	Location *	WS

JP on WS shoulder for removed pump switch house.

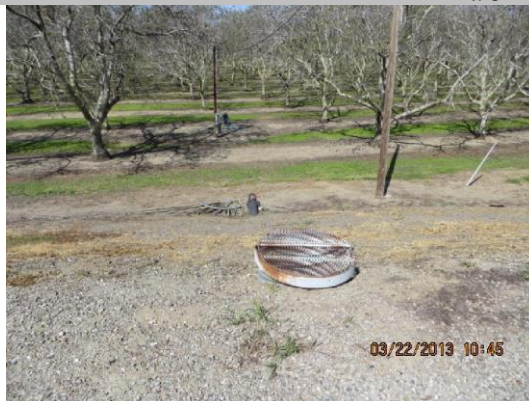
Photo 1 of 2 : UCIP_SP_2016_10566_17954.jpg

LM Start	48.38	Rating **	M	Issue No.	1578
LM End	48.38	Issue Type +	En	Location *	WS
Category	Supplemental			GPS Latitude/Longitude	
				Start	End
Item	DWR UCIP Field Study			39.203761 °	39.203761 °
				-121.985220 °	-121.985220 °
DWR ID					
Comment Code					
Inspector Comment					
FS_ID:10566 DS_ID:20300 EP_NO: 9343 Repair Type: Non-Urgent Crossing Status: Found UCIP Comments: Pipe appears to be abandoned. Need to verify type of abandonment. FIELD_STRUCT_DESC: 2 of 2: 24-inch pipe through levee 15.5 feet below crown (pipe measures 12-inch on LS toe). Slant pump on steel piling structure on the waterward bank. Butterfly valve at toe of the landward slope. Overhead power line crosses the levee. (ABO No. 9343, 1960) Originally included in the 1960 O&M manual. FS Date: 3/22/2013

Siphon Breaker in 30-inch CMP riser on LS shoulder and butterfly valve at LS toe.

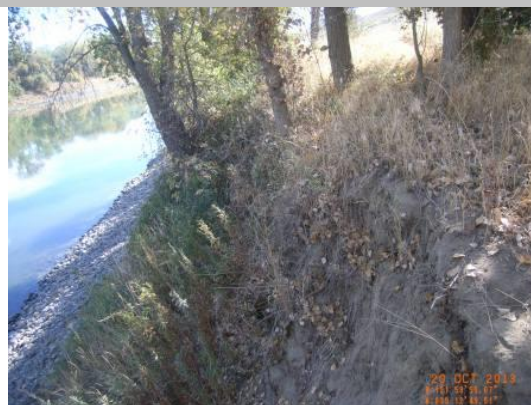
Photo 1 of 1 : SP_2016_NA0016_435_19_20160304_00019.jpg

LM Start	49.46	Rating **	M	Issue No.	19
LM End	49.57	Issue Type +	Ma	Location *	WS
Category	Supplemental			GPS Latitude/Longitude	
				Start	End
Item	2015 USACE Erosion Survey, DRAFT			39.213608 °	39.213869 °
				-121.997543 °	-121.999641 °
DWR ID	DWR_NA0016_01_s _ 2016_19				
Comment Code					
Inspector Comment					
2011 - Multiple scallops, one tree pop out. Old cobble site starting to unravel at midbank. 2012 - Mid bank slumping continues to worsen but cobble at the toe appears stable. 2015: No observed changes. [2015 Site ID: SAC_143-5_R]

USACE 2013 Photo #1
